FPO-1-78(18)

SQUAW MOORING PROJECT
FINAL REPORT
VOLUME 1

**FPO-1-78(18)
SEPTEMBER 1978**

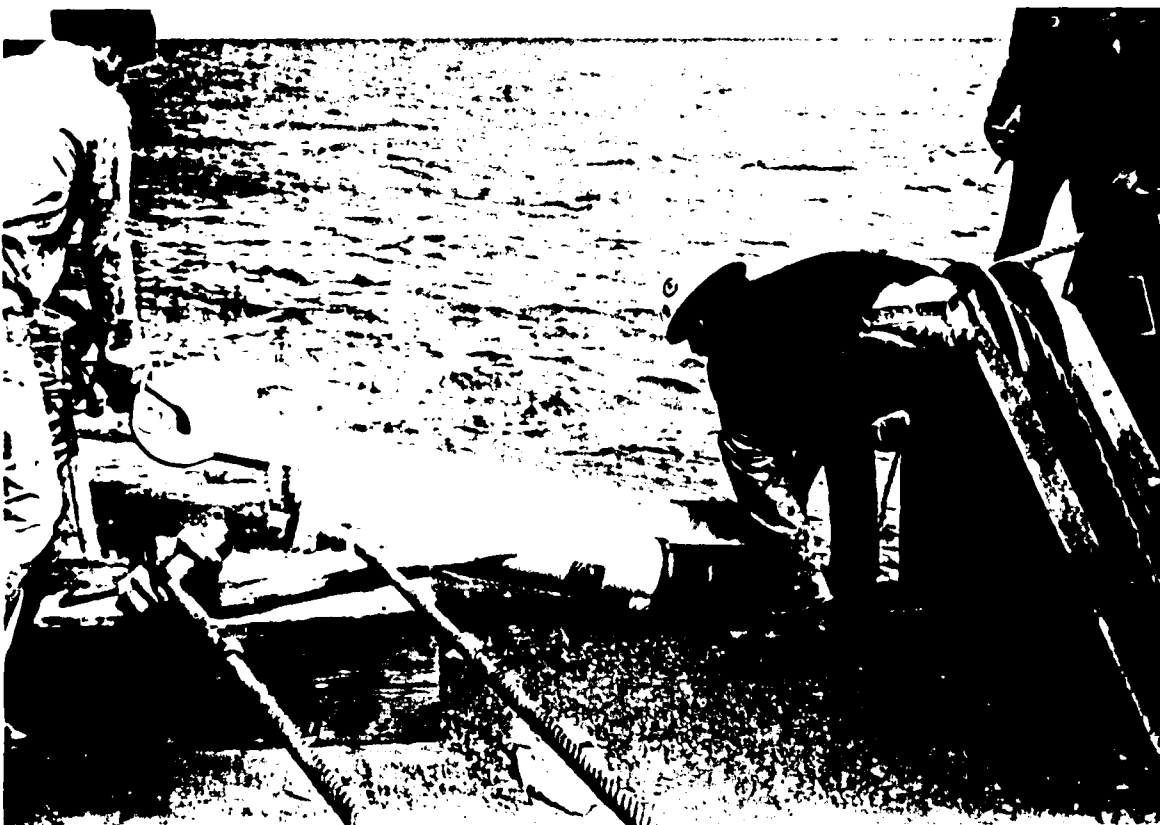
Next the acoustic release was inserted in the line and put overboard, Figure 12. As lowering started the line jerked significantly as the wedged-in wraps on the winch drum came loose, causing the acoustic release to open and dropping the load to the bottom. This occurred at about 1530 when fortunately the *MANATI* was very close to the prescribed north anchor position, Part V.

FIGURE 12. THE ACOUSTIC RELEASE INSERTED IN THE CROWN LINE

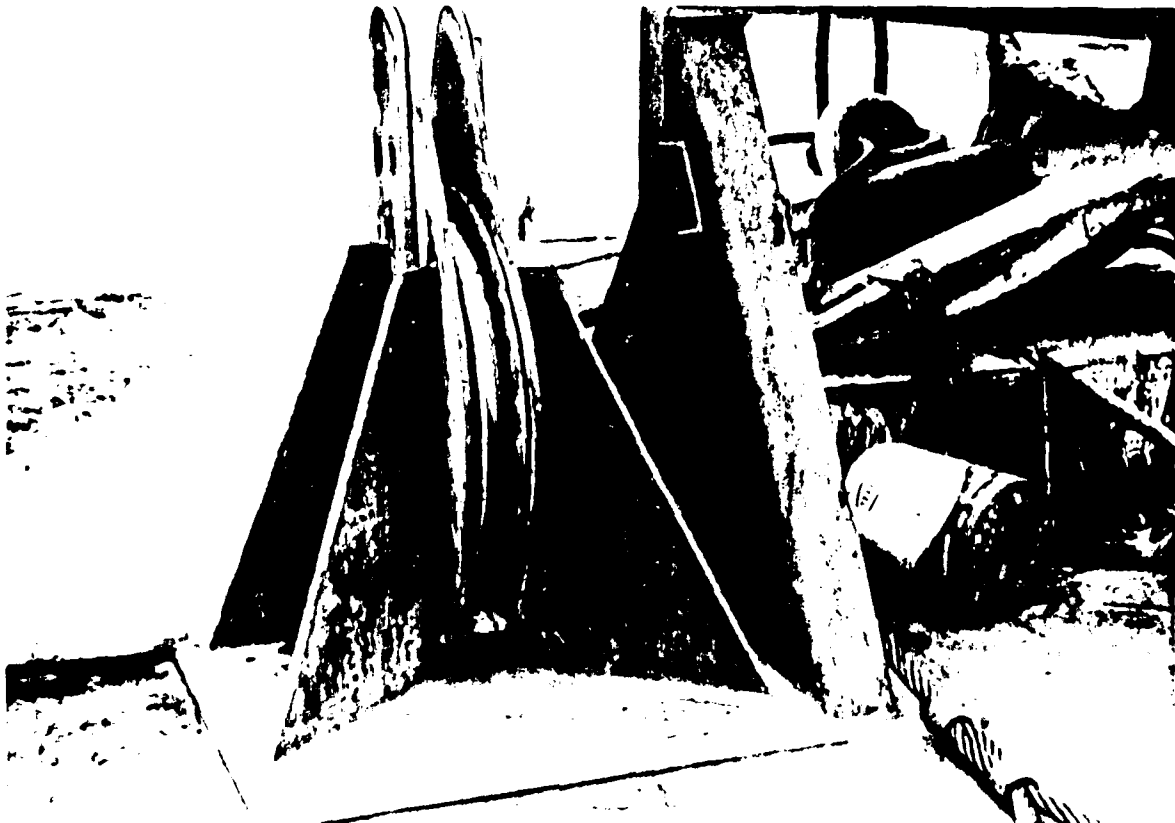
FIGURE 24. REPLACEMENT SHEAVE INSTALLED ON MANATI TRANSOM

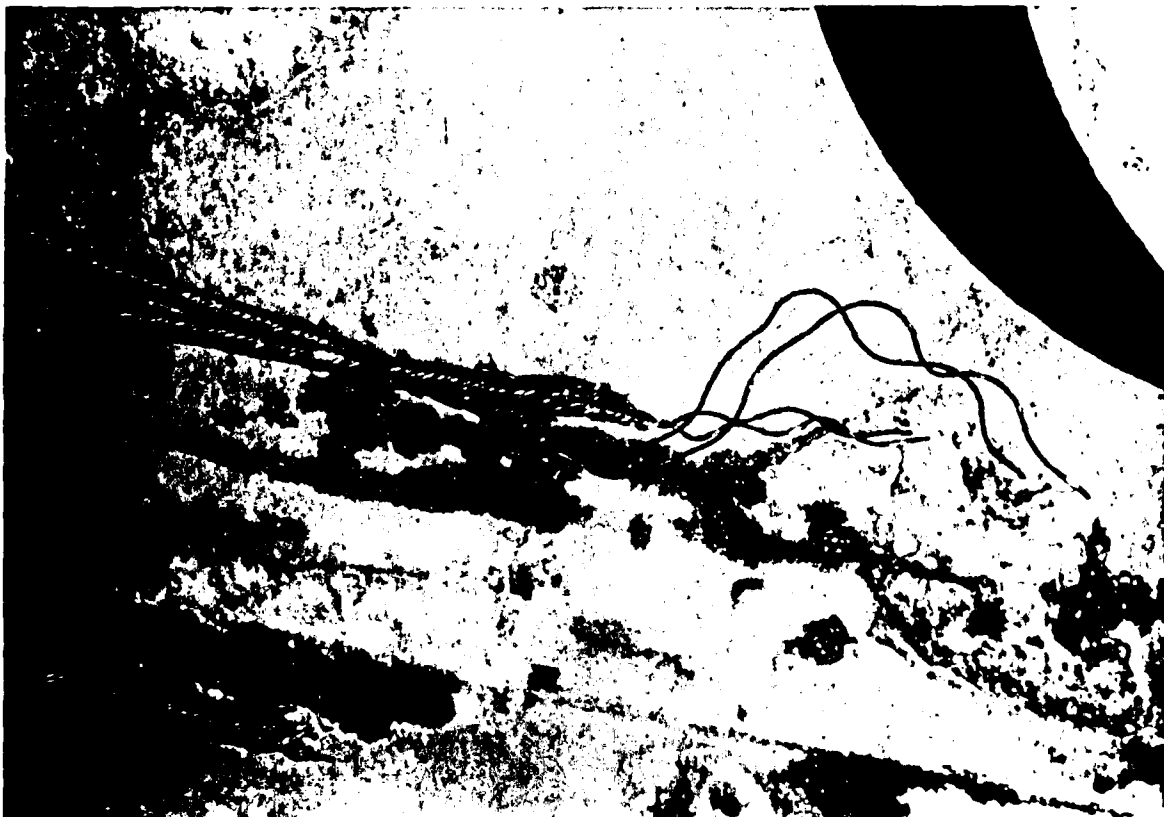
FIGURE 33. ENDS OF THE STERN MOORING WIRE ON MANATI DECK

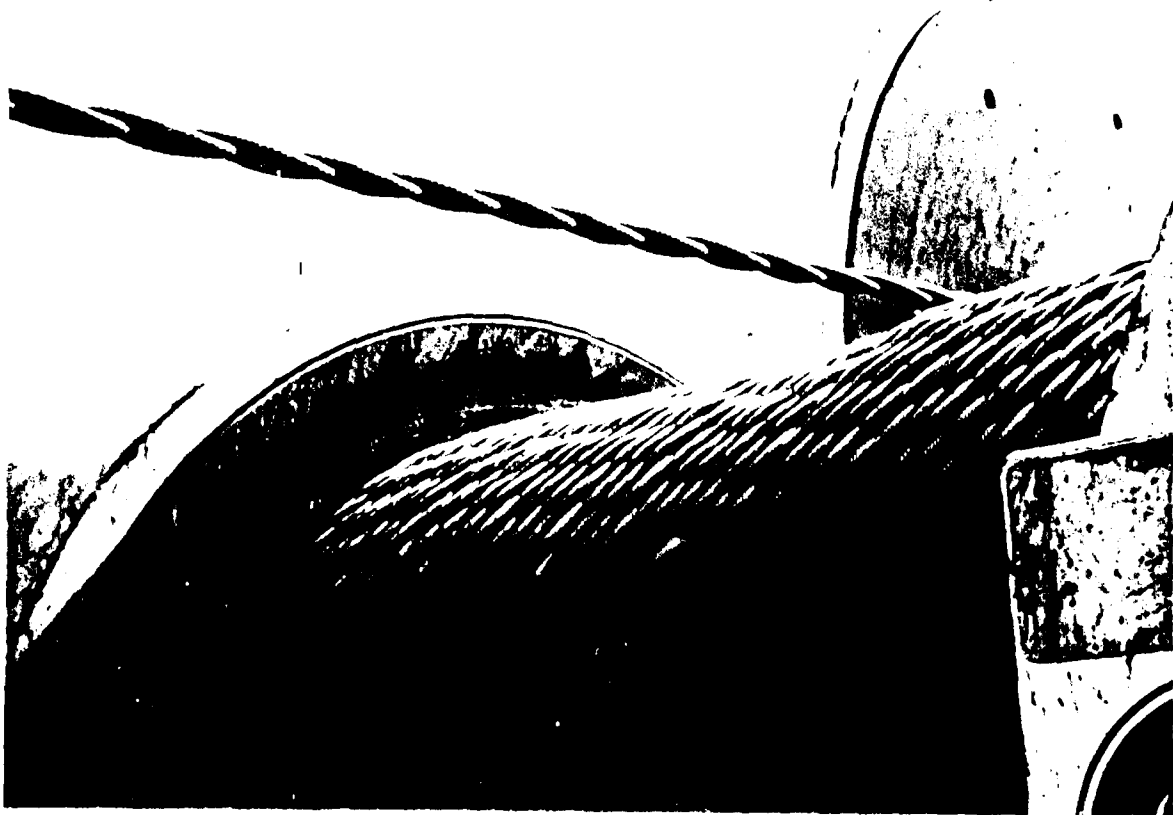
Angles were welded to the anchor flukes to permit it to skid more easily over the deck and stern. However, when tension on the line was eased, the anchor still toed into the pipe fairing over the stern and stood up on the tip of one fluke, Figure 11. The weight of the anchor, chain, and 6000 pound clump caused the 1 1/8 inch crown line to dig into the lower wraps on the winch drum.

FIGURE 39. TIGHT WRAPS OF CROWN LINE ON LOWER WINCH DRUM

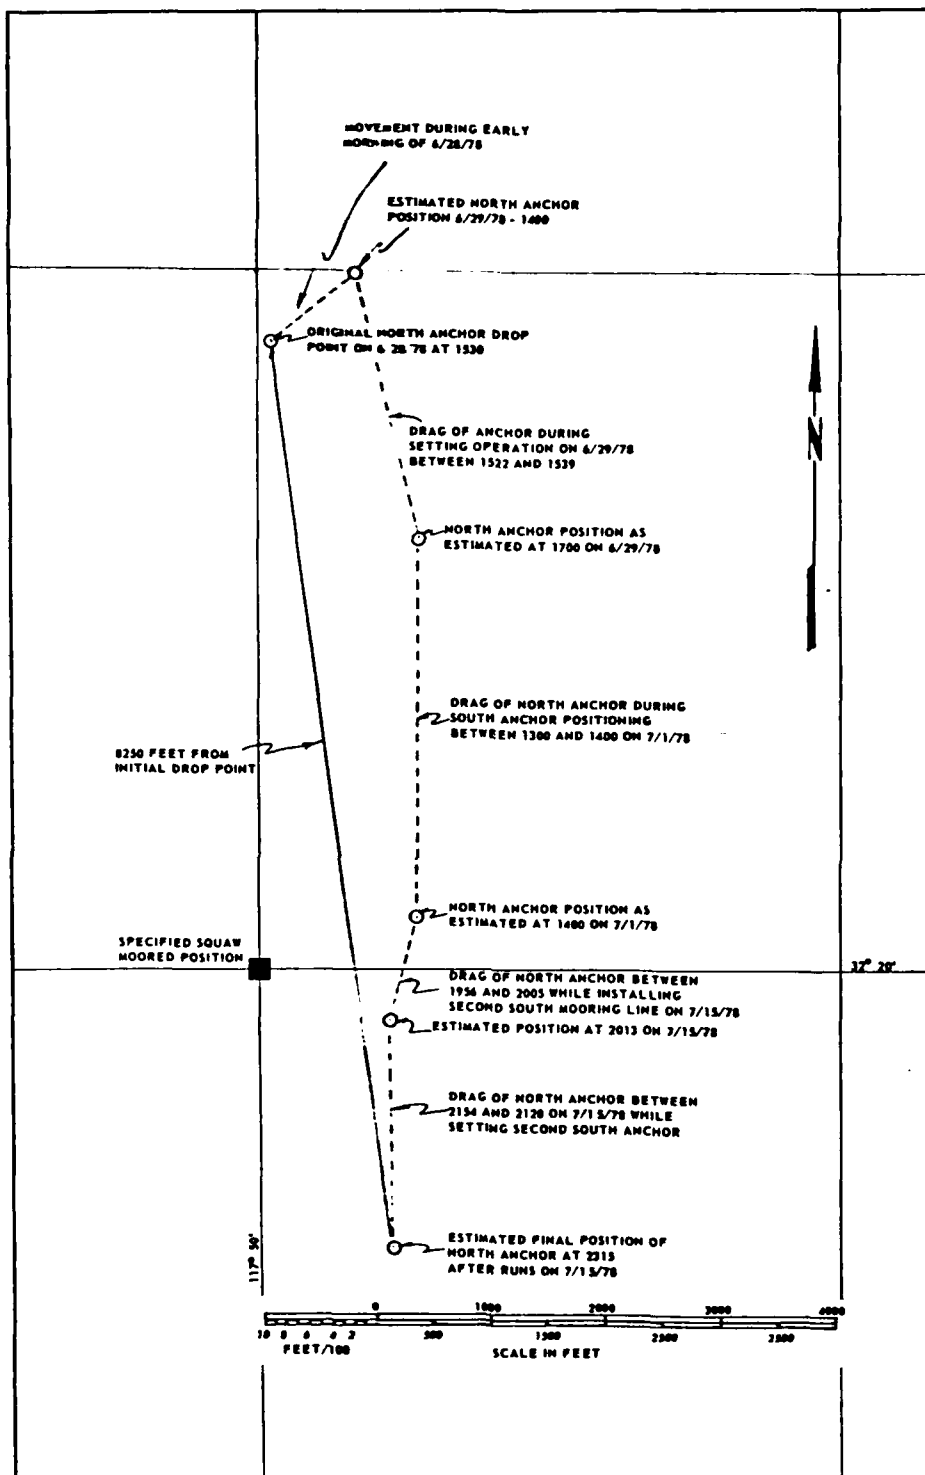
However, many of these position estimates were made on the assumption that the bow mooring line dropped in a continuous catenary down to the chain, the clump, and the anchor. It now appears that the after vertical leg crossed over the bow mooring line when it was lowered and therefore, the weight of the counterweight significantly altered the bow mooring line catenary. Later, the forward vertical leg and its lowering line also apparently crossed the bow

FIGURE 49. VARIOUS MOVEMENTS OF THE NORTH ANCHOR
